# REPORT

on trees at

The Pryors, East Heath Road,  
London, NW3

for

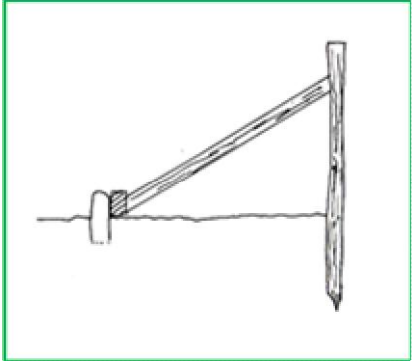
NO.	TREE	HT.	TRUNK DIA.	COMMENTS / ACTION
1	holly	6.4m	280mm	Holly leaf miner noted but not a serious pest. Growing normally. Extension growth of 50mm.
1a	silver maple	5m	60mm	Tree planted between bays 2 and 3. This will be a very large tree at maturity, and in my opinion is almost totally unsuitable for the location. A spread of 15m is quite likely at maturity. Stakes redundant. (See 3a.)
2	holly	9.1m	380mm	Holly leaf miner noted but not a serious pest. Moderate vitality.
3	Dawyck beech	12.2m	326mm	Well-established maturing tree.
3a	Dawyck beech	7.5m	123mm	<p>Planted 2007. Establishing well. Current staking to 'protect' tree is ineffective. Strongly recommend guard stakes replaced with arrangement as shown:</p>

<p>This would tend to prevent regular displacement. The verticals – the stakes – could be wrapped or padded to protect cars) This should be adopted for all the young trees in the car park area that have guard stakes nearby.</p>

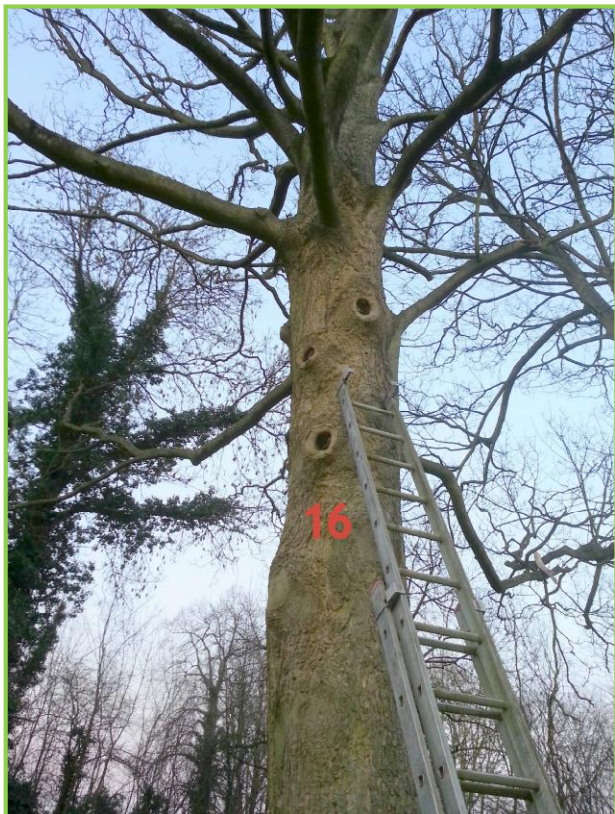
NO.	TREE	HT.	TRUNK DIA.	COMMENTS / ACTION
16	sycamore	19	835	Centres of pruning wound on trunks up to a Height of about 5m above ground level noted to be partially decayed but no fungal fruiting bodies noted. No evidence of fungal fruiting bodies present.

<p>Minor reduction via thinning of upper extremities 'drop crotching' was recommended to make crown more compact, and to address greater exposure following removal of former tree 17 (sycamore). I recommended last year : reduce to no less than 17m in height and accordingly in spread <u>but not less than 10m</u> in its E-W dimension. (In N-S to around 7m radius on N side + <u>no</u> reduction on S side).</p> <p>Tree surgery carried out satisfactory although tree is still 19m in height and over 10m in east / west spread and over 7m in northerly spread. I do not consider the crown to be insecure. Future tree surgery may be required as the tree balances its growth.</p>

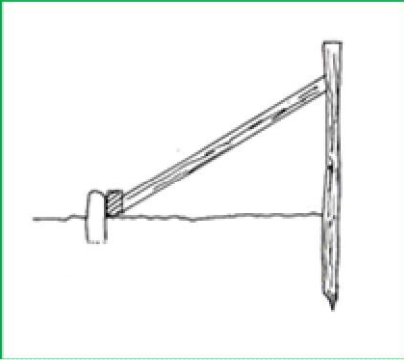
NO.	TREE	HT.	TRUNK DIA.	COMMENTS / ACTION
1a	silver maple	5m	60mm	<p>Recommend guard stakes replaced with arrangement as shown:</p>

<p>This would tend to prevent regular displacement. The verticals – the stakes – could be wrapped or padded to protect cars)</p>
3a	Dawyck beech	7.5m	123mm	
4	Dawyck beech	11m	245mm	
5	Oriental plane – <i>Platanus orientalis</i> 'Minaret'	5.3m	82mm	
6	purple beech	8m	108mm	Protect with guard stakes at corners of surrounding grid. (Replace soil for 3m around trunk and to 600mm in depth – method provided in section 05.)
8	Norway maple	17m	683mm	Crown clean.
9	honey locust ('Inermis')	17m	300mm est.	Crown clean and prune to clear scaffold by 2m.
17a	<i>Liquidambar</i> spp.	3.6	40mm	Move tie points down to 500mm above ground level and shorten stakes accordingly.
21	red oak	16m	335mm	<p>Crown clean the tree.</p> <p>Replace hedge below the tree with yew and <i>Pyracantha</i> (thorny) mix.</p>
